Technical Report CHL-99-3

Monitoring Completed Navigation Projects Program

Inspections of Previously Monitored Coastal Structures

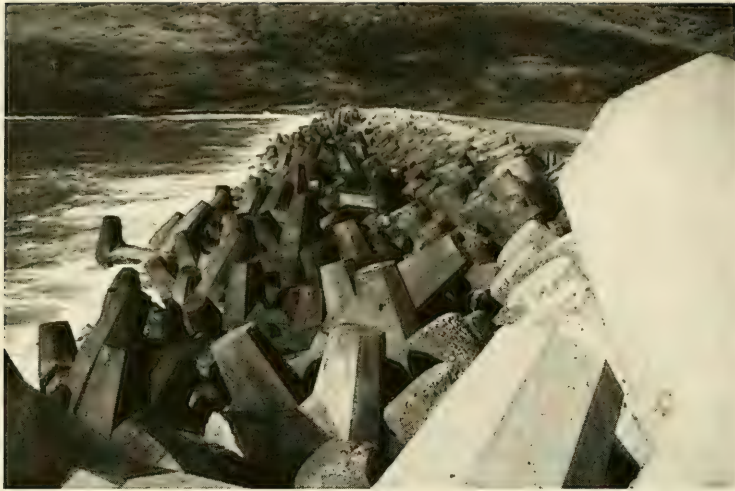
The breakwater (Figure 3) was inspected on 22 July 1998. The inspection indicated that most of the armor units were in similar positions as recorded during the 1995 survey based on detailed photogrammetric maps of the structure. Numerous broken armor units were observed, but were validated as those documented in the 1995 survey. Fragments of some of the broken armor units were still in the same locations as observed in 1995. It was noted that the older 16,150-kg (17.8-ton) tribars are showing major surface spalling of concrete (Figure 4), but this is not felt to put the structure in any danger of instability. Overall the structure is in good condition.

Figure 3. Sea side of Nawiliwili Harbor breakwater

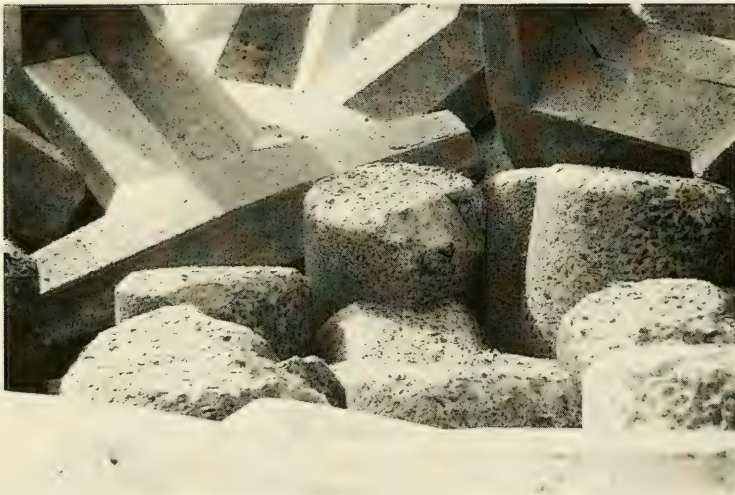
Figure 4. Surface spalling of tribars on Nawiliwili breakwater

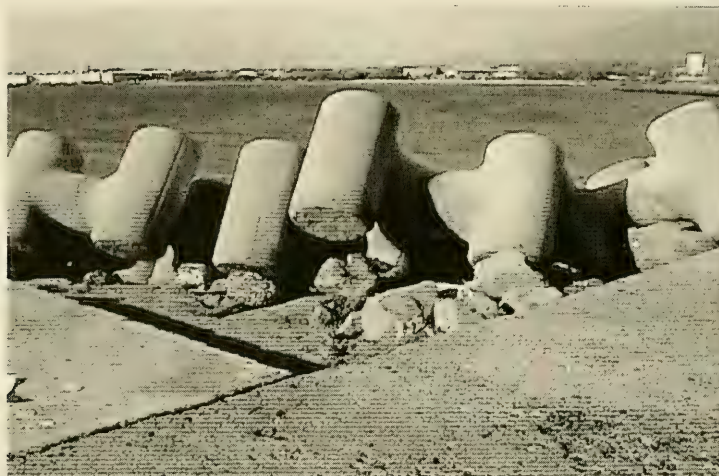
(sta 6+20 thru 7+10) on the sea side of the structure was noted since the 1993 survey. Eleven broken units were observed in this area as opposed to nine documented broken units during the 1993 survey. During the west breakwater inspection, a concentration of broken 27,215-kg (30-ton) dolosse was noted on the sea side of the head. Twelve broken/cracked units were observed versus eleven documented during the 1993 survey. Also, some of the 5,900-kg (6.5-ton) tribars on the harbor side of the breakwater close to its head appeared to have lifted and tilted downslope

(possibly due to overtopping waves, Figure 8). No voids and breaches were noted in the breakwaters, and the overall condition of both structures was considered good.

Figure 8. Tribars that appear to have tilted downslope (Kahului west breakwater)

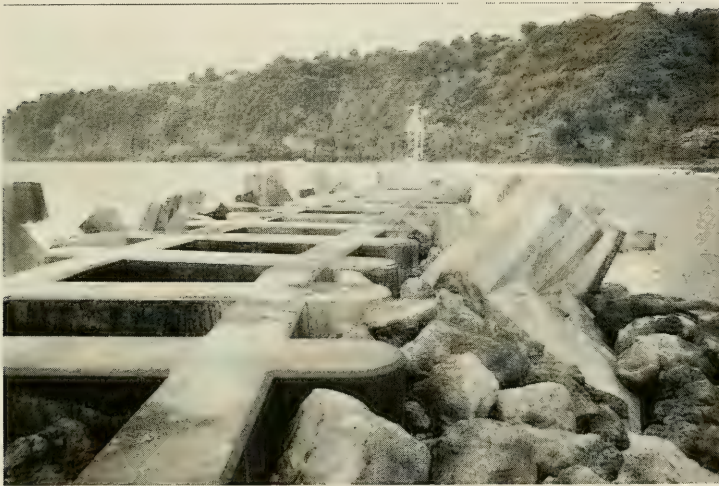
The Laupahoehoe breakwater (Figure 10) was inspected 22 July 1998. The inspection indicated that the armor units were in the same positions

Figure 10. Laupahoehoe breakwater

as documented in the 1993 survey. No broken armor units were observed, and the structure is considered to be in excellent condition.

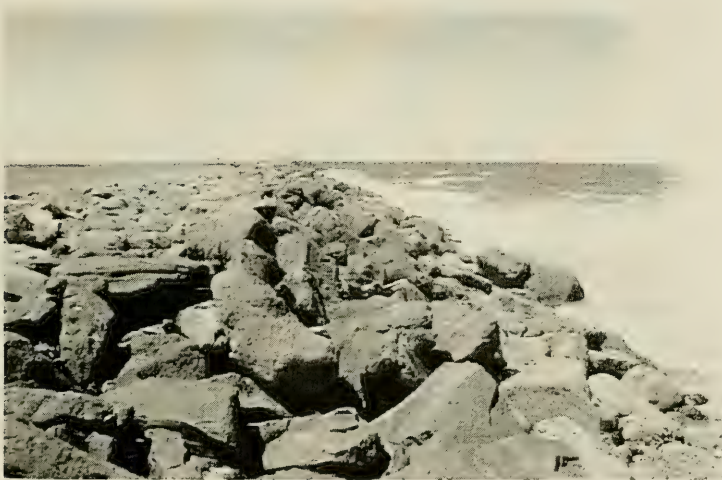
An inspection of the north jetty (Figure 12) on 24 June 1997 revealed that the head of the structure no longer existed. Comparisons to photogrammetric data obtained in May 1993 indicated that approximately 50 m (165 ft) of the north jetty head was no longer above water, and stone had apparently been removed to below the water level by wave action. When the notch area was not visible, measurements from known locations on the structure were made to confirm this finding. Remnants of some of the jetty could be seen seaward of the structure in wave troughs as they passed. Above-water stone around the head was not uniform (Figure 13). Other observations of the structure revealed some low areas in the crest and some voids on the sea side of the jetty. At a location approximately 305 m (1,000 ft) shoreward of the jetty head (the head location of 24 June 1997), low areas in the crest existed over about a 30.5-m (100-ft) span.

Figure 12. Yaquina Bay north jetty

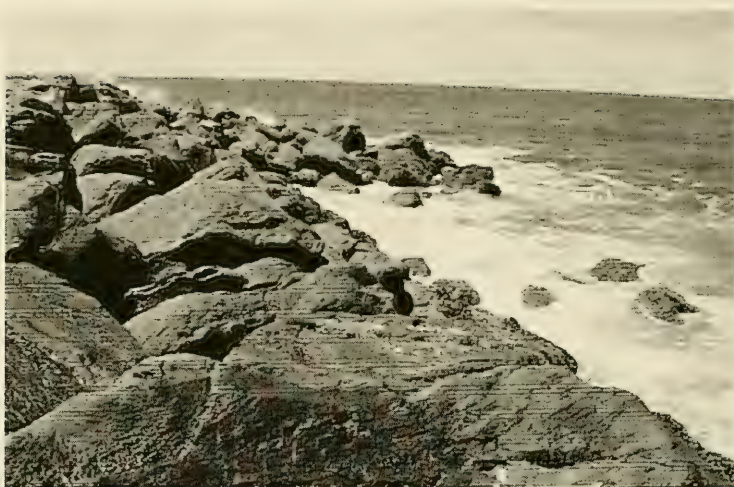
Figure 13. Head of Yaquina Bay north jetty on 24 June 1997

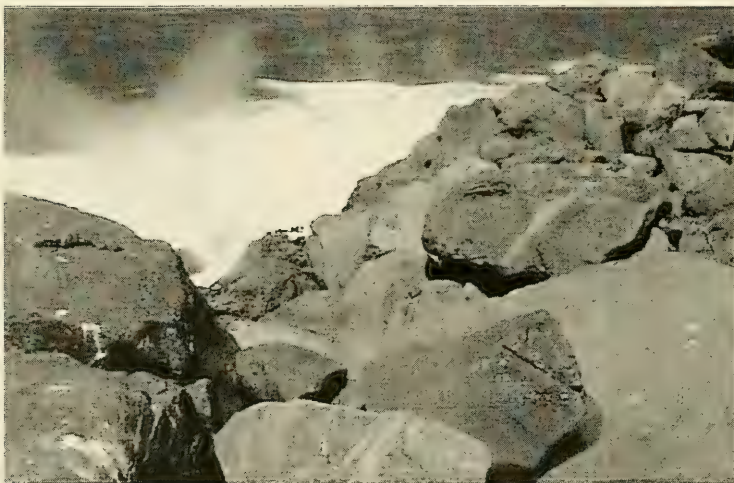
Another low area was observed on the crest about 520 m (1,700 ft) shoreward of the jetty head, and a void on the sea side of the jetty was observed approximately 580 m (1,900 ft) from the jetty head (Figure 14). An even larger void on the sea side of the structure was observed about 650 m (2,125 ft) shoreward of the jetty head as shown in Figure 15.

Figure 14. Void on seaward side of Yaquina north jetty observed approximately 580 m (1,900 ft) from head

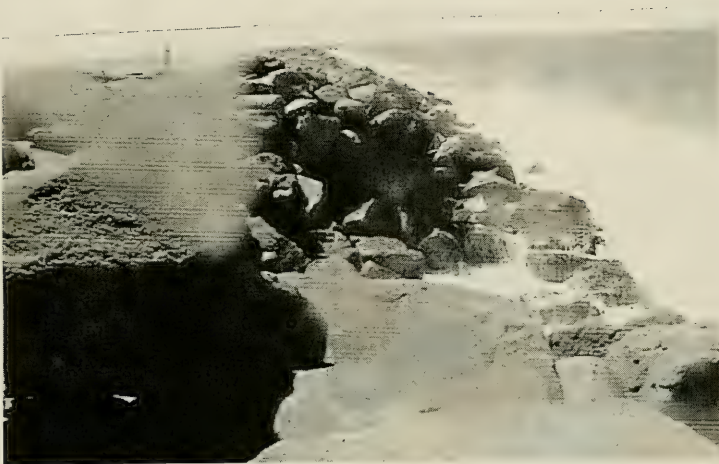
Figure 15. Void on seaward side of Yaquina north jetty observed about 650 m (2,125 ft) from head

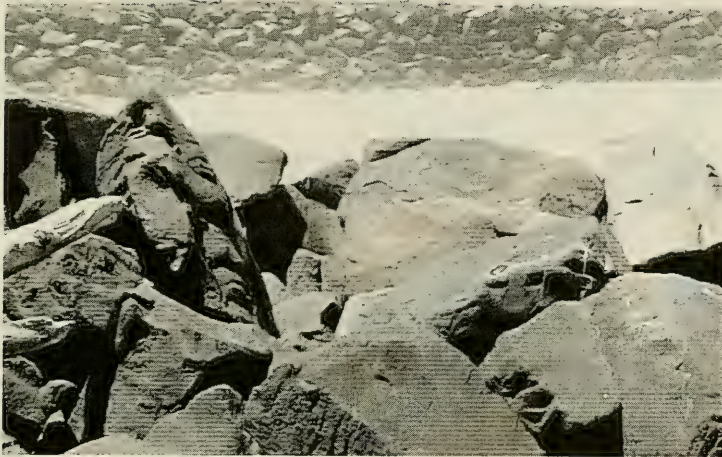
Figure 17. Displaced stone on north jetty spur at Siuslaw

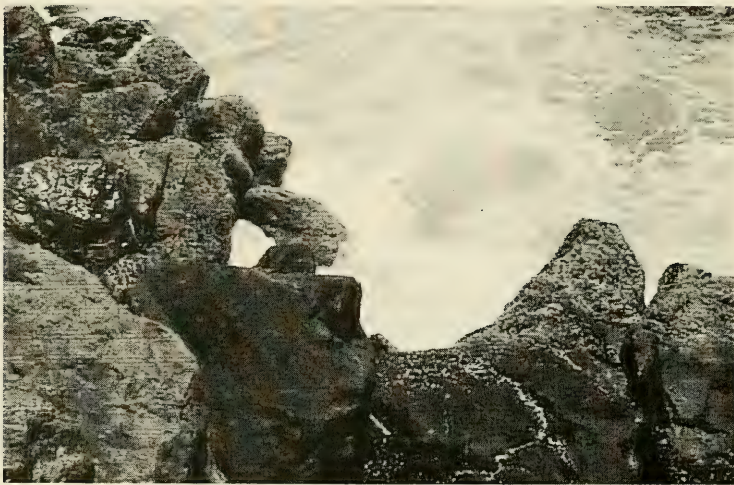
An inspection of the jetty system on 26 June 1997 revealed that some repairs were needed. On the north jetty head, a void was observed on the channel side of the structure. The area was steep, and it appeared that stone had been pulled downslope by wave action as remnants could be seen seaward of the area. About 20 m (65 ft) shoreward of the jetty head, a low area in the center of the crest existed; and approximately 27.5 m (90 ft) from the head a void existed on the channel side of the structure. In several areas along the jetty extension, it appeared that the center portion of the crest had subsided and the elevation was irregular. The stone along the slopes, however, appeared to be up to required elevation. At a point about half the length of the jetty spur, it appeared a stone had been uplifted leaving a small void (Figure 17). With the exception of the jetty head, the slopes on the north jetty extension and jetty spur were in good condition. Inspection of the south jetty extension indicated a similar situation at the jetty head on the sea side of the structure. The slope was very steep, and it appeared that stone had been pulled downslope by wave action (Figure 18). The head of the south jetty spur also was damaged on its shoreward side as evidenced by a lack of stone above the water surface (Figure 19). In addition, immediately shoreward of the jetty spur head, a void existed on the shoreward side of the spur (Figure 20). The side

Figure 20. Void in south jetty spur at Siuslaw

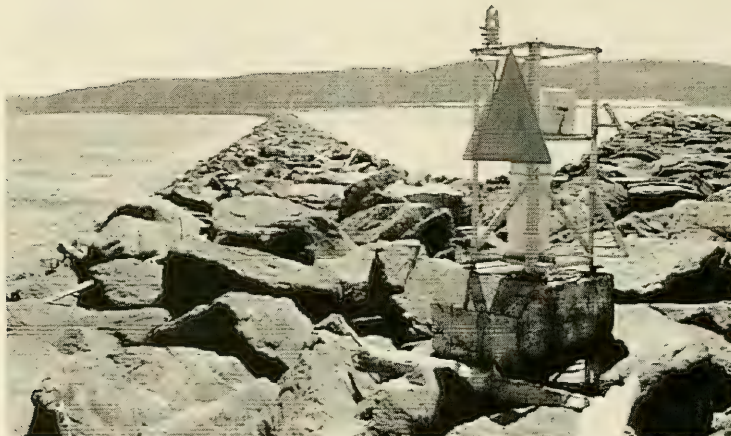
The training jetty and south jetty were inspected on 25 June 1997. Inspection of the training jetty revealed that the 1980 extension was in very good condition (Figure 22). Its cross section appeared to be uniform along its length, and very few of the armor stones had cracked. The shoreward portion of the structure (1951 construction) had some areas that appeared to be damaged on the shore side. This was prevalent immediately landward of the shoreline where stone from the back side of the jetty was scattered (Figure 23). The channel-side face of this portion of the training jetty was in good condition. Inspection of the south jetty revealed a

Figure 22. View of Umpqua River training jetty (left structure) looking shoreward

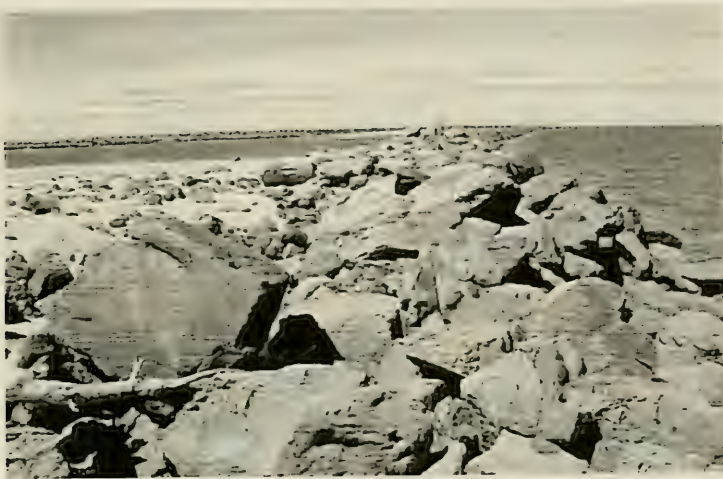
Figure 23. Scattered armor stone on shore side of Umpqua training jetty

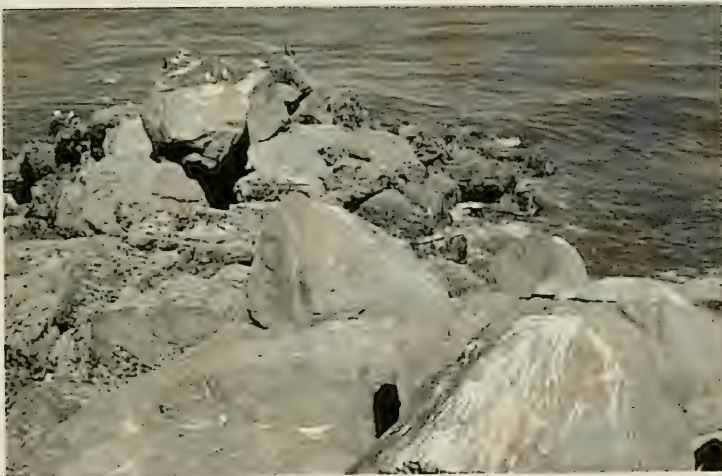
breach at its head. The breach did not extend below the water level, but extended through the jetty (Figure 24). In addition, just shoreward of the breach, a large void existed on the sea side of the structure (Figure 25). The trunk of the south jetty was in good condition.

Figure 24. Breach at head of Umpqua River south jetty

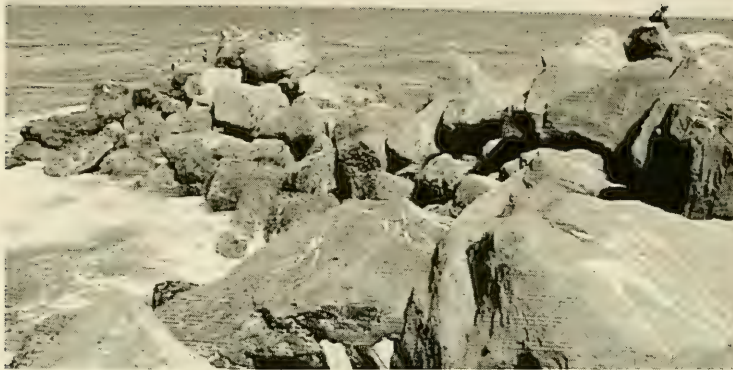
Figure 25. Breach and void at head of south jetty at Umpqua River

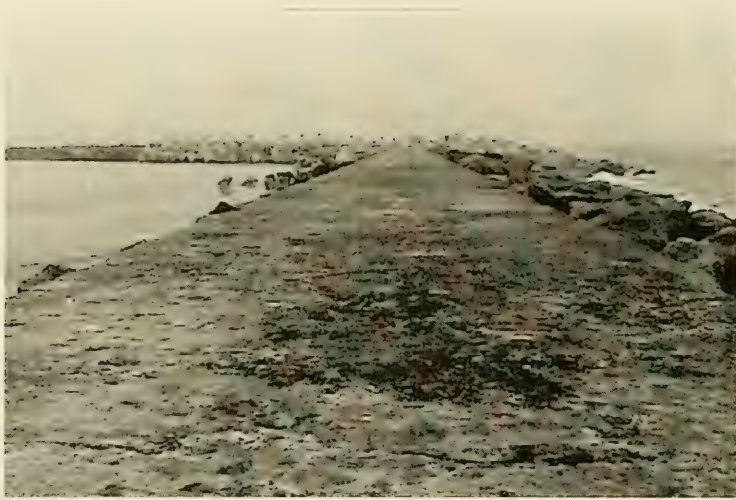
The Crescent City Harbor breakwater (Figure 27) was inspected on 15 September 1998. The inspection indicated that most of the armor unit positions were similar to those shown in the 1993 photography as close as could be observed visually. It appeared that only a couple of the 38,100-kg (42-ton) units had changed positions slightly along the waterline at the outer portion of the main stem. Figure 28 shows some of these units at the head of the main stem of the breakwater. Numerous broken armor units were observed, but were validated as being broken in the 1993 survey. Overall the structure is in good condition.

Figure 27. Crescent City Harbor breakwater

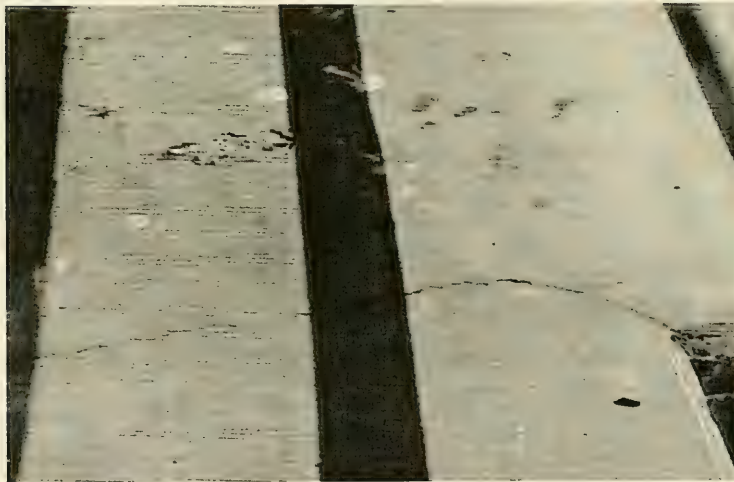
The Spud Point Marina breakwater (Figure 30) was inspected on 16 September 1998. The assessment revealed no evidence of misalignment, movement, spalling, or subsidence of the structure. The hairline cracks across the top of the breakwater cap noted in the earlier surveys did not appear to have widened (Figure 31). Additional hairline cracks were observed, particularly on the vertical sides of the cap. Some of these cracks

Figure 31. Hairline crack across cap of Spud Point Marina breakwater

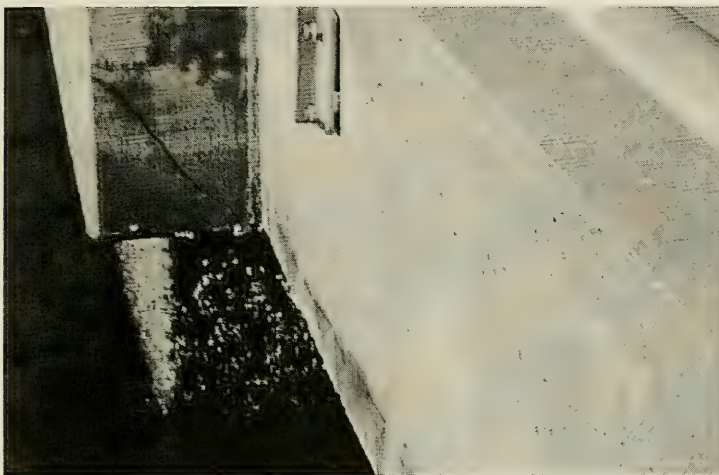
were vertical, but the majority were horizontal cracks formed about 152 mm (6 in.) above the bottom edge (Figure 32). Stains on the concrete along some of these hairline cracks indicated that some of the rebar is rusting in these areas. Cracks along the baffled sections and batter

Figure 32. Example of cracks noted in vertical portions of concrete cap at Spud Point Marina breakwater

piles were not visible due to the buildup of barnacles on the structures. There is no evidence that the hairline cracks in the breakwater cap are threatening the integrity of the structures. Overall, the structure appears to be in very good to excellent condition.

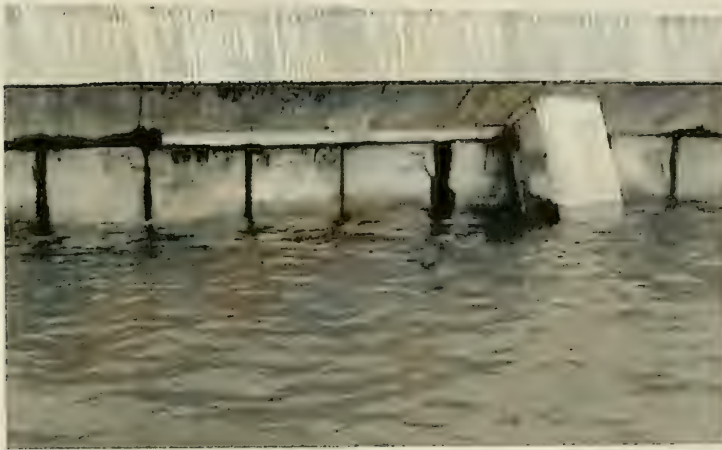
Figure 35. Spalling of concrete piles between the breakwater cap and the water surface at Fisherman's Wharf Harbor

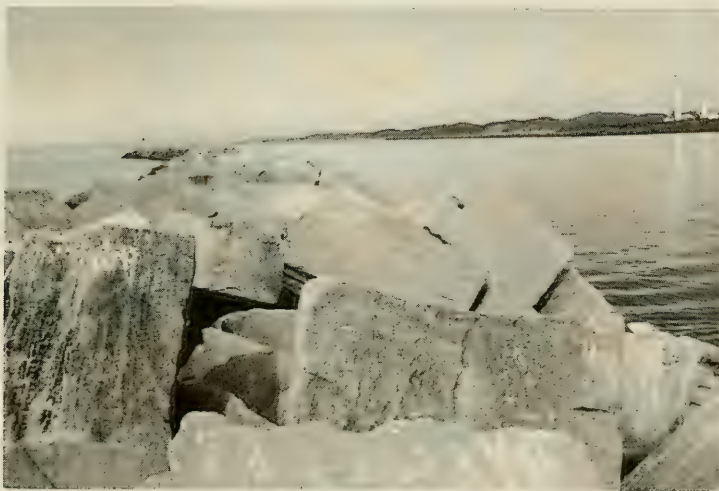
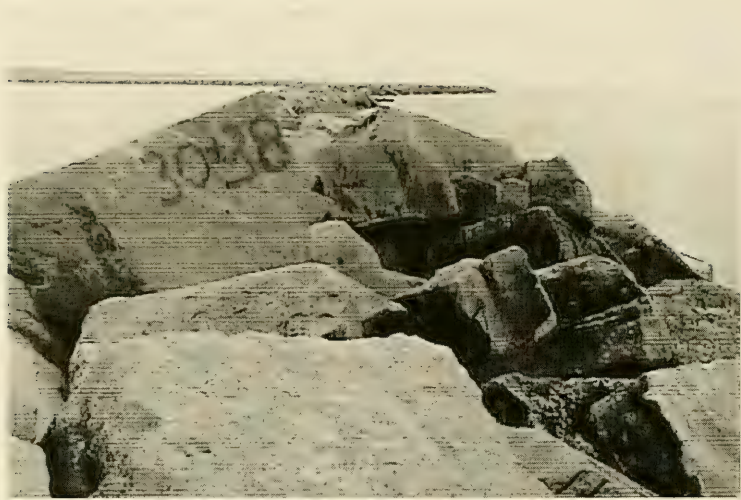
The Burns Harbor north breakwater (Figures 37 and 38) was inspected on 17 June 1998. The elevation of the breakwater was compared to topography data obtained previously during the photogrammetric analysis. Sections of the structure in which it appeared that low areas existed since the last inspection are shown in the following tabulation.

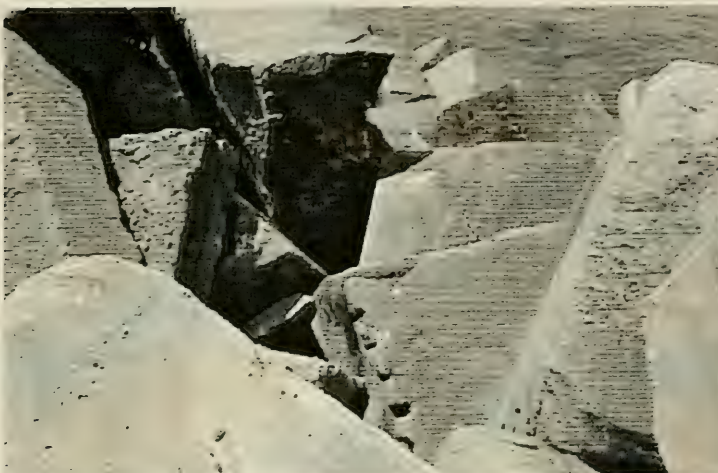
The inspection also indicated several voids in the breakwater. Figures 39 and 40 depict typical voids in the Burns Harbor structure. It appeared that continued deterioration of the breakwater had occurred since the last inspection.

Figure 39. Void on lakeward crest of Burns Harbor breakwater

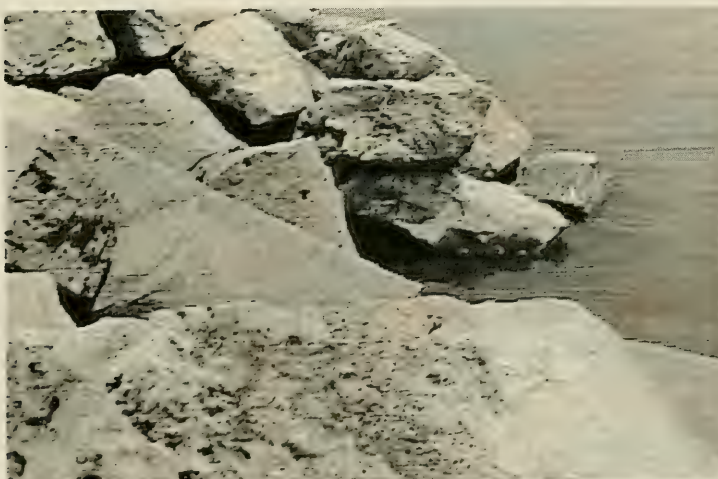
Figure 40. Typical void in harbor side of Burns Harbor breakwater

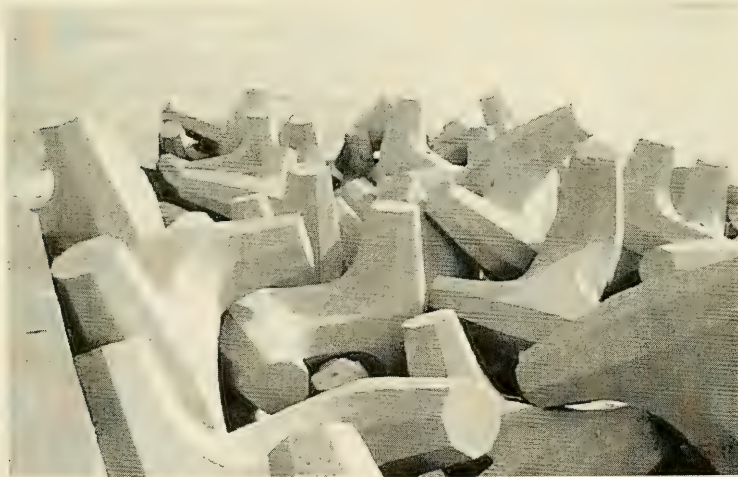
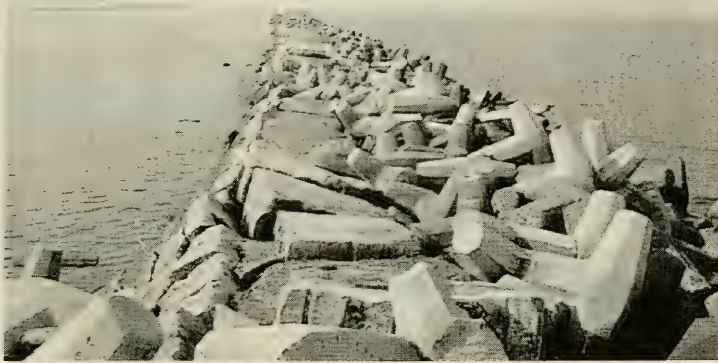
The Cleveland Harbor east breakwater (Figures 42 and 43) was inspected on 7 October 1997. The inspection revealed that the structure has changed little since the 1993 survey. Comparison of armor unit positions

with detailed, rectified aerial photography, in general, revealed that most of the armor units were in the same position as in 1993. Even fragments of broken dolosse were in the same positions based on the aerial photographs. Apparent armor unit movement was observed at only one location along the structure. At sta 262+55 one dolos had moved downslope slightly and an adjacent dolos had flipped upslope. It was also noted that some new 3,628-kg (4-ton) dolosse had been placed between sta 253+50 and 254+00 since 1993. The structure is in fair to good condition and appears to be functioning well.

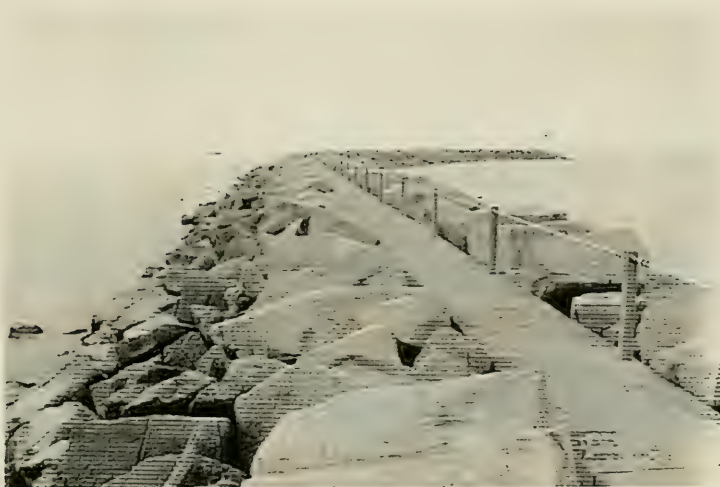
An inspection of the Cattaraugus Creek Harbor south breakwater (Figure 45) on 8 October 1997 revealed voids in the armor stone layer at two locations on the lake side of the breakwater along the curved portion (sta 15+00 and sta 16+50). The void at sta 16+50 is shown in Figure 46. An additional void was observed on the head of the structure (Figure 47), which resulted in a steep slope. During the inspection several broken stones were observed sporadically along the structures; however, overall the structure appears to be in good condition. The north breakwater was inaccessible and not inspected. It is protected by the curved south structure.

Figure 45. Cattaraugus Creek south breakwater looking lakeward

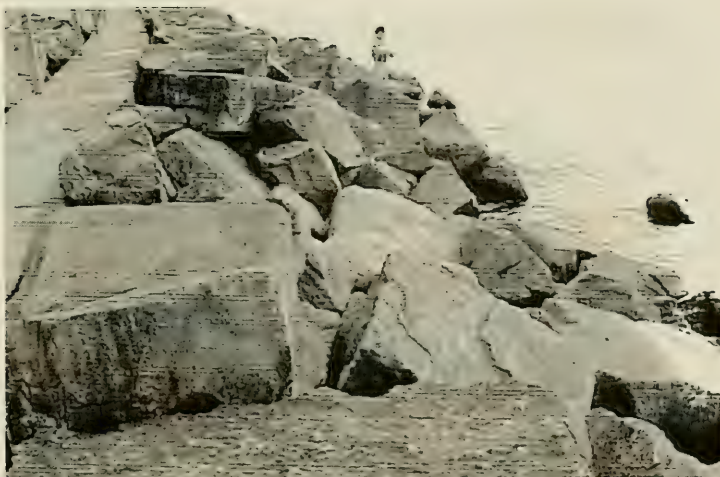
Figure 46. Void along trunk (sta 16+50) of Cattaraugus Creek south breakwater

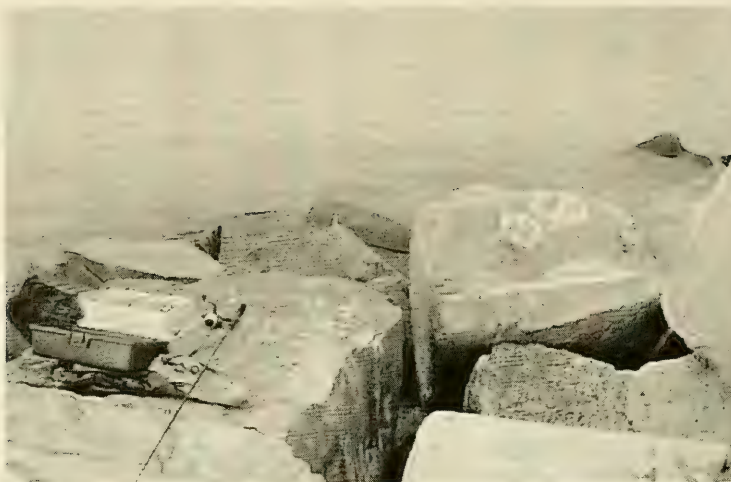
Figure 47. Void and steep slope at head of Cattaraugus Creek south breakwater

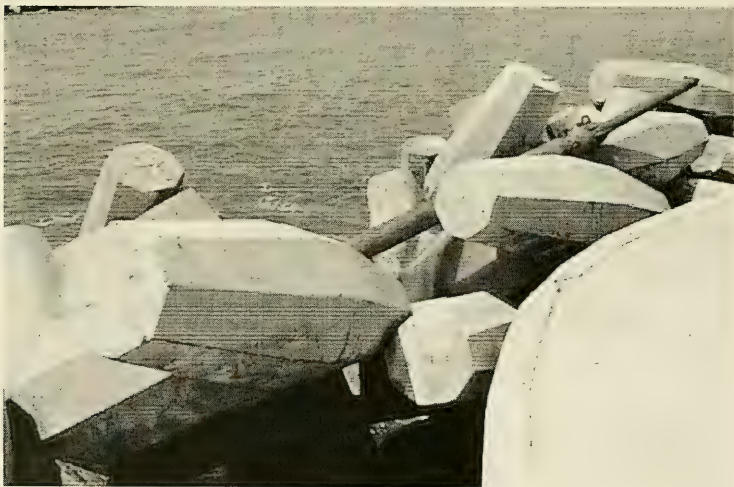
elevation. Seven of these units were adjacent to the void area (Figure 50) on the south side of the jetty head, which had been identified in the 1994 survey. The void area also appeared slightly larger than in 1994. Two armor units on the north side of the structure and four on the seaward tip of

Figure 50. Void area on south side of Manasquan Inlet north jetty head

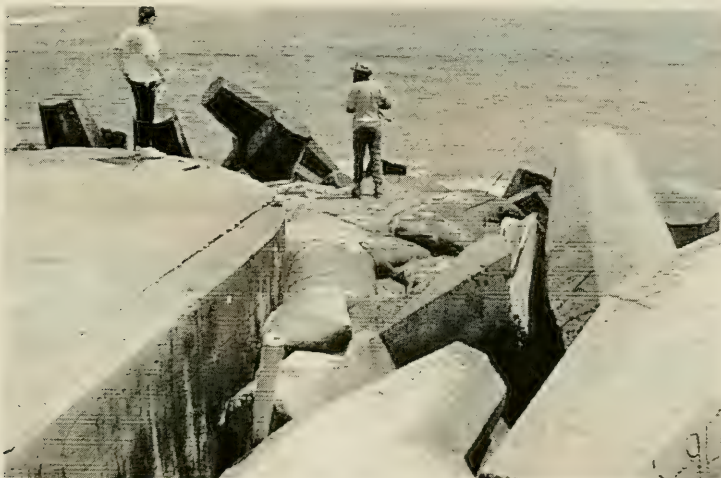
Figure 51. Emergency repair work (grout-filled bags) at head of Manasquan Inlet south jetty

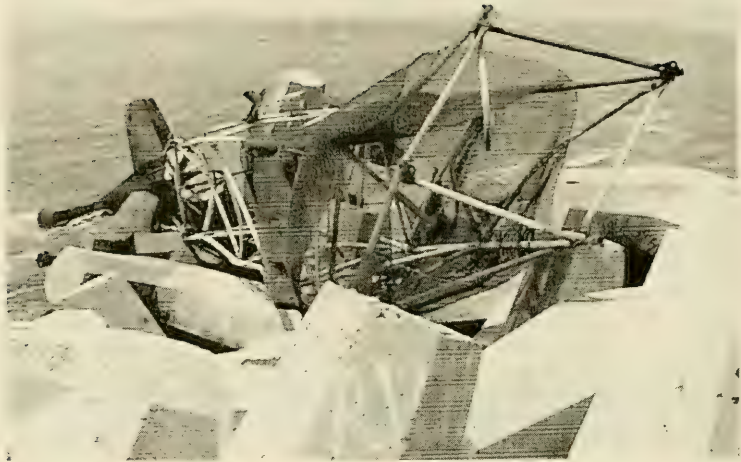
Figure 52. Lighthouse base washed into Manasquan Inlet south jetty as a result of 1995 storm

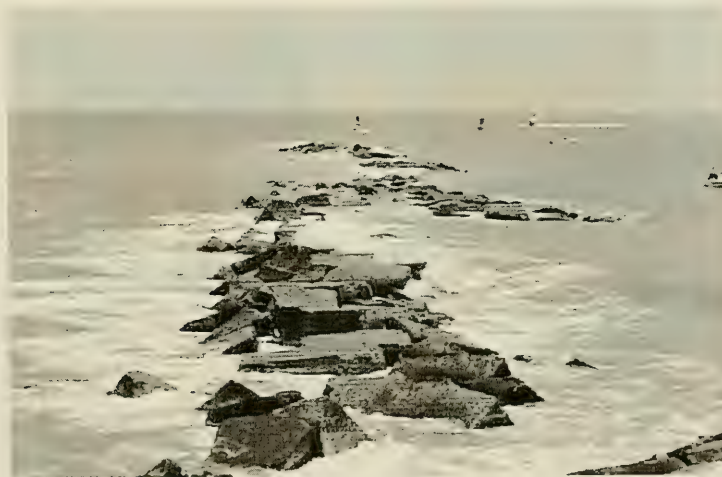
The rehabilitated south jetty and headland breakwaters at Ocean City Inlet were inspected on 11 June 1997. The rehabilitated south structure is shown in Figures 54 and 55, and the headland structures are shown in Figure 56. The inspection revealed these structures to be in excellent condition. No voids were noted, no armor stones were broken, and the cross sections of the structures appeared to be as built. It was noted that the seaward section of the old south jetty (that extending beyond sta 13+00) was in disarray. Armor stones were scattered, the crest height was inconsistent, and no definite cross section was apparent (Figure 57).

Figure 57. Seaward section of existing south jetty at Ocean City Inlet (beyond sta 13+00)
